INTER-OFFICE MEMORANDUM

DATE: April 30, 1968

SUBJECT: MAINTENANCE PROBLEMS - MOFFETT BOULEVARD SEWER

MAIN AND LATERALS

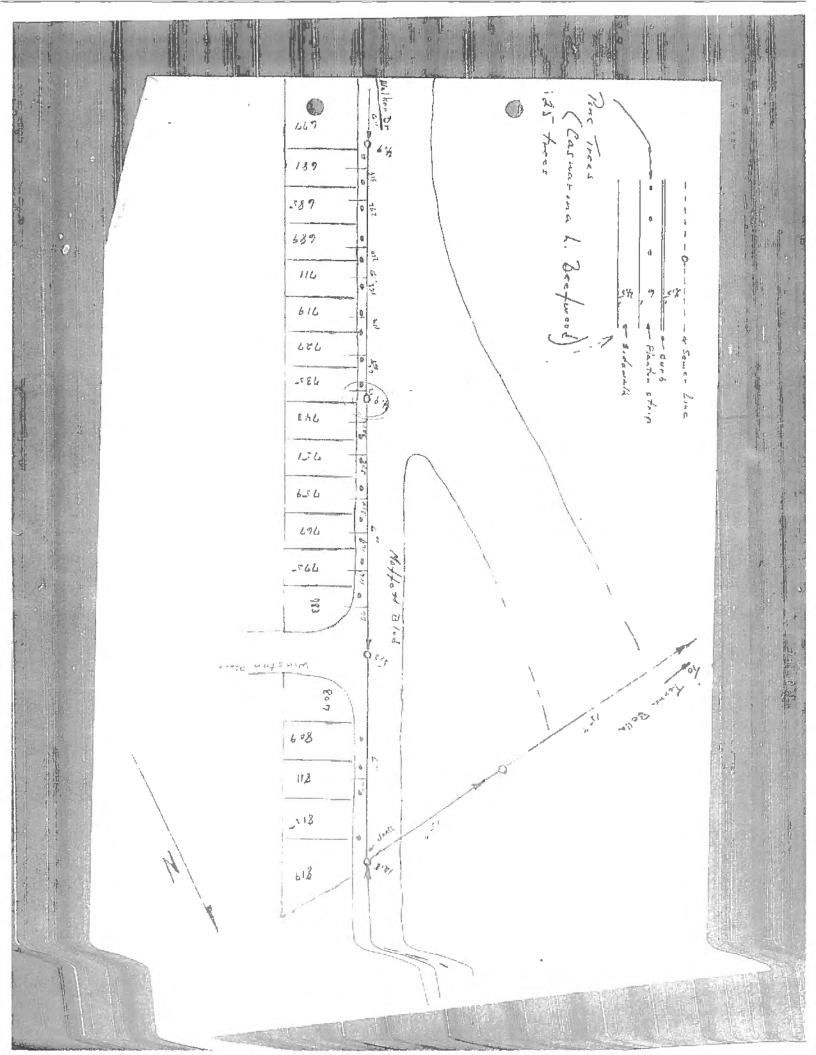
The attached sketch shows the sewer line on Moffett Boulevard now serving eighteen residences. The main is fairly shallow and is 2.5 feet west of the curb. There is an existing sidewalk with a six foot planter strip between the curb and sidewalk. The planter strip contains twenty-five pine trees (Casuarina L. Beefwood) spaced approximately as shown with trunk diameters varying eight to sixteen inches.

The root system of these trees has caused an increasing maintenance problem. The six inch main is now rodded every thirty to sixty days to remove root growth and minimize the stoppages occurring in the sewer main; however, our greatest problem is in the laterals. Stoppages caused by root growth are occurring between the sewer main and the back of the sidewalk. Our maintenance records for the past year show thirty-five lateral stoppages. In the past five years we have replaced four six-foot sections of main line and twelve of the eighteen house laterals have been partially or completely replaced on the City side. We are now having repeat stoppages on these laterals due to root growth.

It is requested that a study of this sewer main be made by the Englineering section for replacement of the six inch main and laterals at a deeper elevation and also removal of the trees causing the extensive damage. The original main and laterals have not pour tar joints.
